Tank maintenance

Our guide to the economical repair of corroded tank bottoms

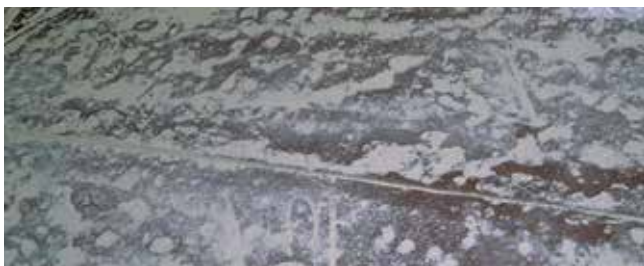
Legend:
Light blue: Caulking compound / stripe coat
Dark blue: Tank lining

In some situations, even after filling the pits, a caulking compound may be required to level the uneven areas. Our PPG NOVAGUARD 830 coating can be applied to all weld seams, lap joints, shell side joints or other surface projections to provide a smooth surface transition.

It is important that an even surface is provided by the caulking compound to assist in the application of the chopped fiber laminate to the tank bottom and joint areas.

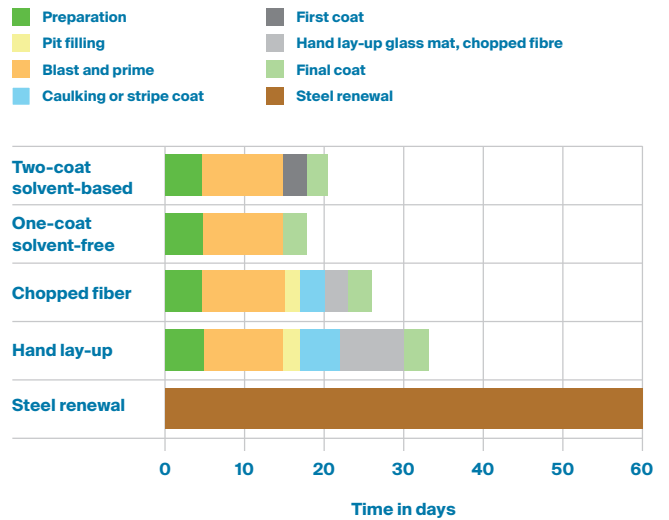
Time for maintenance: 2,750 m² (9,022 ft²) tank 30m (98.4 ft) diameter.

The above clearly shows at least 50% saving in time when using our chopped fiber system, compared to steel renewal. Moreover, the material and application of our chopped fiber system is cheaper, resulting in further cost savings for tank farm operators.

Compared to the amount of time the tank is out of service for various maintenance options, it is clear that repairing tank bottoms with a sprayed chopped fiber laminate is extremely economical, as demonstrated in the comparison below:
